The role of coastal vegetation in case of the Indian Ocean tsunami -Coastal area of Thailand and Sri Lanka-

Yasushi Sasaki¹⁾, Samang Homchuen²⁾ and Norio Tanaka¹⁾

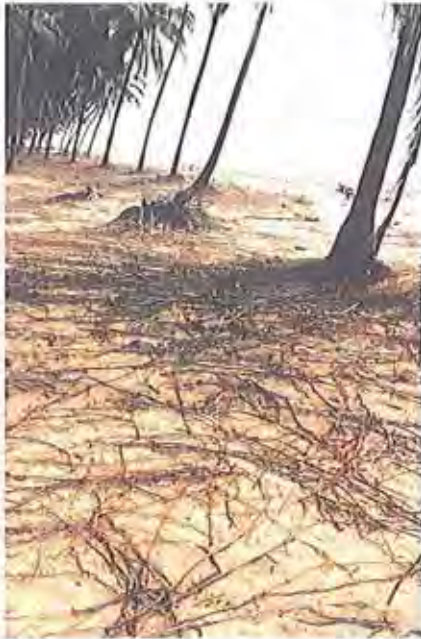
Fig. 2. Only surface sand has eroded by the tsunami at front of sand dune, *Cocos nucifera* forest, in Rekawa Sri Lanka

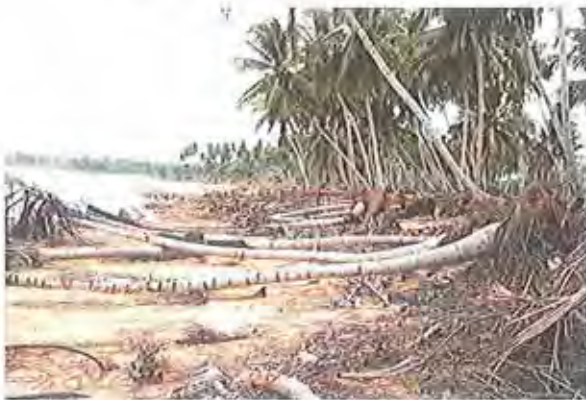
Fig. 3. Rare case of coconuts trees has been fallen to sea side by backflow of tsunami, In Rekawa, Sri Lanka

leaves even in lower points, such as *Terminalia catappa*, *Pongamia pinnata*, *Pandanus odoratissimus*, *Anacardium occidentale*, have fallen down very little. Fallen vegetation are concentrated on the most front vegetations even in the area, where experienced larger tsunami and greatly damaged. In these cases, fallen trees are mainly in the side road of water flows such as rivers or small waterways, and it results in soil erosion at these roots. The vegetations in Rekawa, Sri Lanka have been fallen backflow of Tsunami, fallen to seaside. However, fallen trees have not been lost from the point by tsunami.

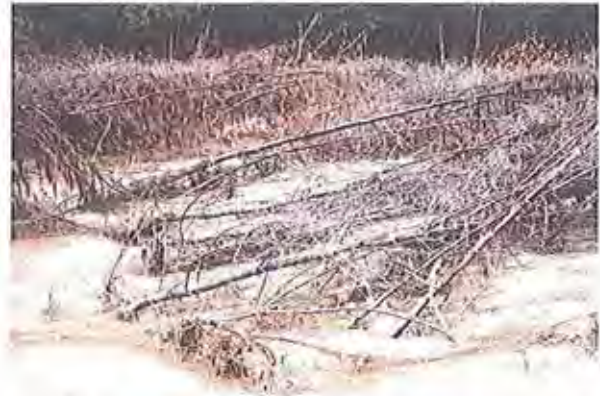
Fig. 4. Rare case of *Casuarina equisetifolia* young trees has been fallen by the tsunami at front of sand dune, but don't flow out in Rekawa, Sri Lanka

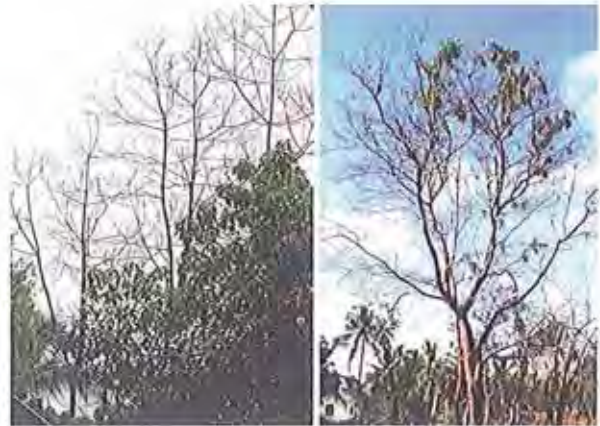
Fig. 5. *Alstonia macrophylla* (left) and *Azadirachta indica* (right) has been died by the tsunami in Sri Lanka

damaged differently from them. Especially, many of *Alstonia macrophylla* and *Mangifera indica* have withered.

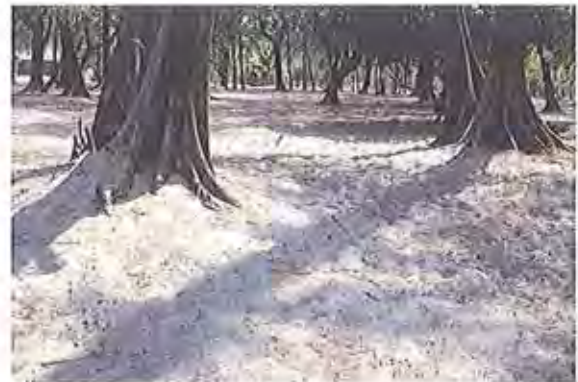
Fig. 8. In the *Casuarina equisetifolia* forest has been deposited sand by the tsunami, in Laem Son, Thailand

sand hill has been eroded and almost connected to backward Lagoons. Those areas are also less vegetated areas. On the other hand, the sand hill area, where plant colonies such as *Ipomoea pes-caprae* and *Spinifex littoreus* have developed, have limitedly eroded within 10 to 20 cm. On the behinds of these vegetations, in *Casuarina equisetifolia* Forests, sand sedimentation has been observed in Laem Son, Thailand.

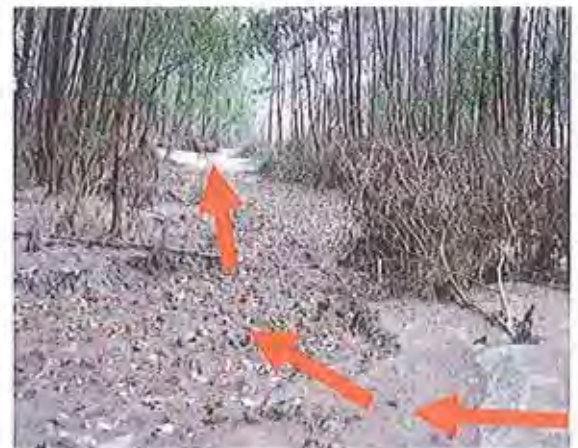
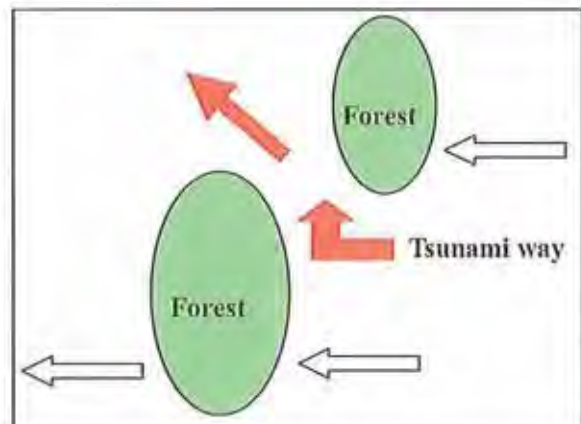
Fig. 9. Coastal vegetation can change tsunami way, In this case is *Casuarina equisetifolia* forest, in Laem Son, Thailand.

Fig. 10. Coastal vegetation can change tsunami way, In this case is *Casuarina equisetifolia* forest, in Laem Son, Thailand.

Vegetations have no ability to repress tsunami, but they will work as wave resistance or changing pathway of tsunami.

Tsunami passing through forests such as coastal vegetations changed its way to less resistant, or less vegetated area,
